## **Tramex Moisture Meter**

The following is an example of the use of the Tramex Moisture Meter, based on tests performed on the locker lids of my own boat.

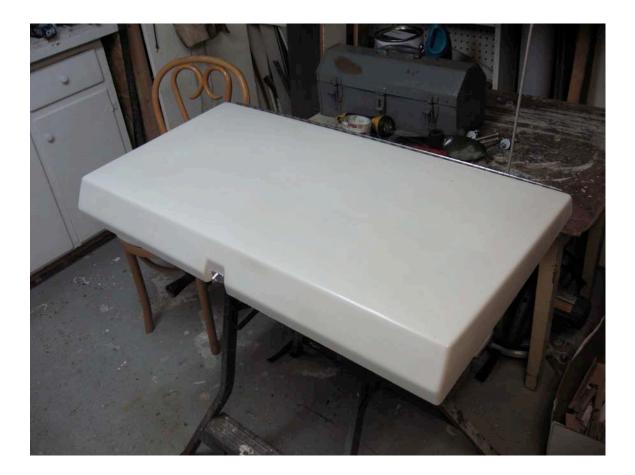
Readings on scale 3 - On one side of the cover, the meter gave a reading of 0 while on the other area, it found readings between 20 and 50, which indicated risk areas. I found the same readings on the underside of the cover.

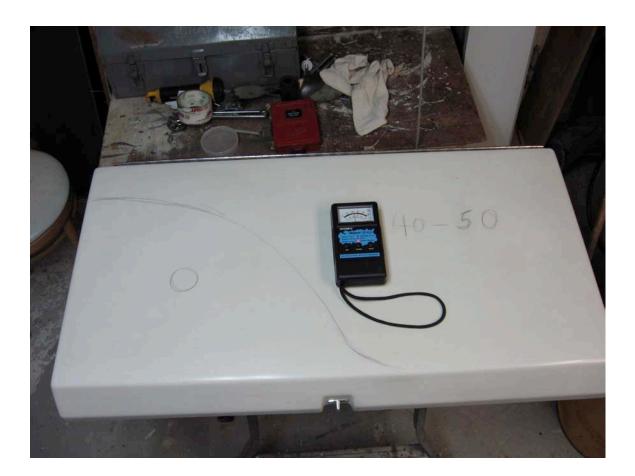
The same readings seen on the underside of the hatch cover. We can easily conclude that these moisture readings are the result of water entering via the piano hinge.

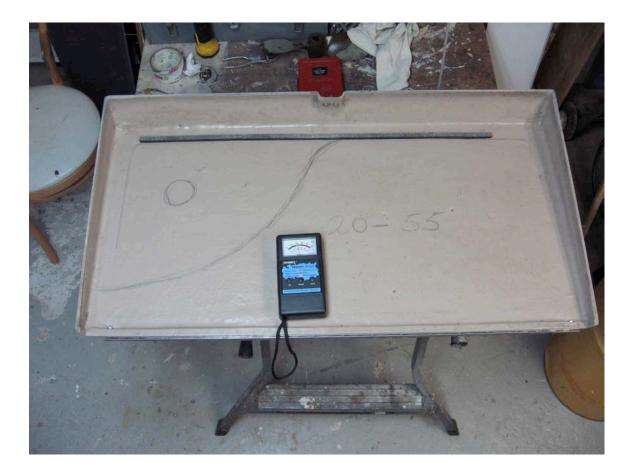
Getting more serious – Using a holesaw, I removed the top layer of fibreglass and bared the balsa within. I chose two locations for the holes, one where the reading was highest (50) and one with a reading of 0.

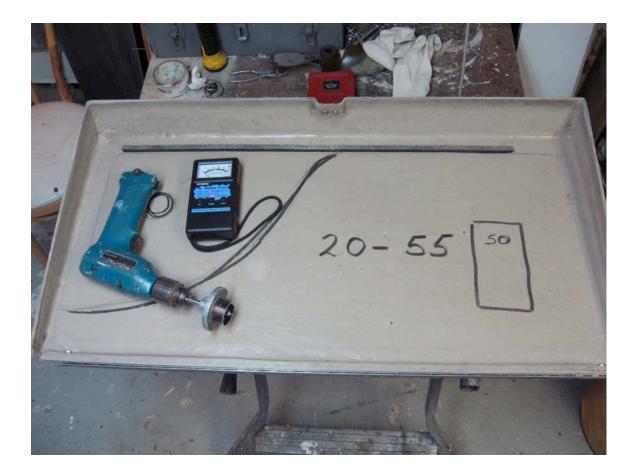
After drilling with the holesaw in the high-reading area, it was easy to remove the fibreglass disc within the cut.

I immediately noticed moisture at this location, but neither delamination nor

mould was apparent.

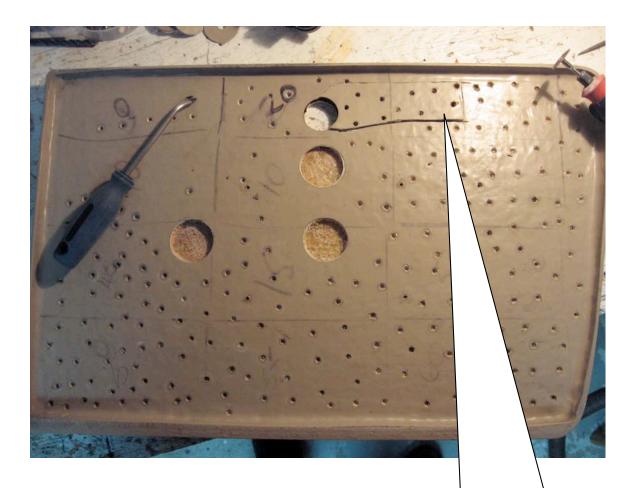
Drilling of these little vent holes produced blackened balsa in some locations, indicating the presence of rot. This section will be completely uncovered and the balsa removed. The whole hatch will be rebuilt once everything is dry.

- After opening up the cover surface, it took a good month of drying before I noticed a fall in the moisture levels. Once completely dry, they were repaired with 3 layers of fibreglass mat and polyester resin. By getting inside the locker and shutting the lid on yourself, you can mark where the flange is and make the repair thin enough at that point that it doesn't interfere with closing.
- The oversize holes for the piano-hinge screws will be filled with epoxy (VC Watertite), which will give them greater strength.
